## CASE STUDY

# Space-Age Enhancement Coating Solves Aluminum Longerons Failures On T-38 Jets

*By Corey Wesnitzer, General Magnaplate Corp.*

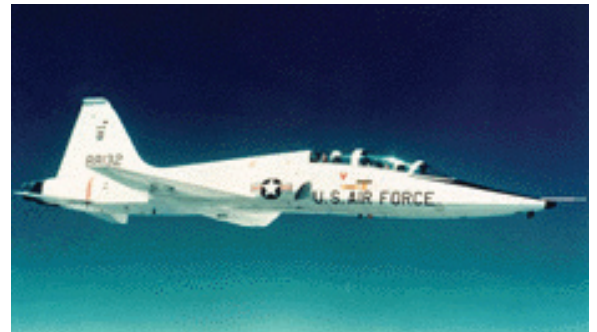
The T-38 longerons are complex parts with multiple fixtures and a curve. Because of the geometric complexities, Triangle Machine and Manufacturing virtually had to sculpt the 12-foot parts using turning, milling, contouring and assembly.

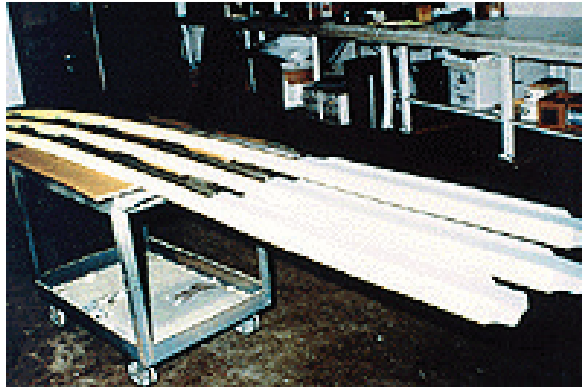
The TUFGRAM® enhanced surface at the center of this longeron - applied at General Magnaplate’s Texas Materials Technology

Center - is gray-colored, and extremely hard (Rc 40-50), extremely smooth and dry-lubricated. It exhibits superior abrasion resistance - greater than that of case-hardened steel or hard chrome plate - and

superior corrosion resistance. The TUFAM surface is also protected against chemical attack, and features permanent non-stick and anti-static properties. Magnaplate also applied primer and finish coats of paint to the non-track surfaces of the aluminum using the latest High Volume, Low Pressure (HVLP) spray painting techniques.
