CASE STUDY

“Made in the U.S.A.” Audio Component Pioneer Redesigns Efficiency

Elastomeric Polymer-Based Surface Enhancement Coating From Magnaplate Doubles Coil Winding Efficiency And Reduces Rejects 75% For Pyle Industries

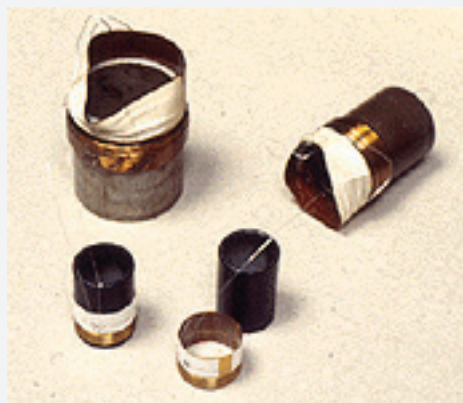
This photo illustrates both the problems Pyle Industries encountered and the solutions General Magnaplate helped them achieve: In the rear left is a voice coil literally glued onto an untreated 6061-T6 aluminum arbor. Note the damage to the coil caused during the attempt to separate the coil and arbor. Often the arbors were “dinged” too, and even though removed, some of them would not fit back on the tooling of the winders. At right rear is an arbor that was black-anodized prior to Magnaplate’s involvement with Pyle. Damage and separation problems due to tenacious glue deposits were also evident with the anodized arbors. In front are two LECTROFLUOR 615 coated arbors. The coil at the right has been easily and efficiently removed from the undamaged arbor manually, saving Pyle twice the time required previously when arbors and coils had to be rammed apart pneumatically.

The basic problem encountered was the adherence of the adhesive to the aluminum arbors. Following baking, Pyle's workers discovered that the coils were adhering tenaciously to the arbors, and the company had to develop a method of forcibly removing the coils.

"So we wound the coils using the LECTROFLUOR 615-treated arbors and we had no problems with them. When we were finished, the coils just slid off the arbors. We could again do the separation by hand."
